GBV Sårbarhetsanalyser og risikohåndtering

Analysis of the 2011 Tohoku tsunami

20081430-00-11-R
31 December 2011

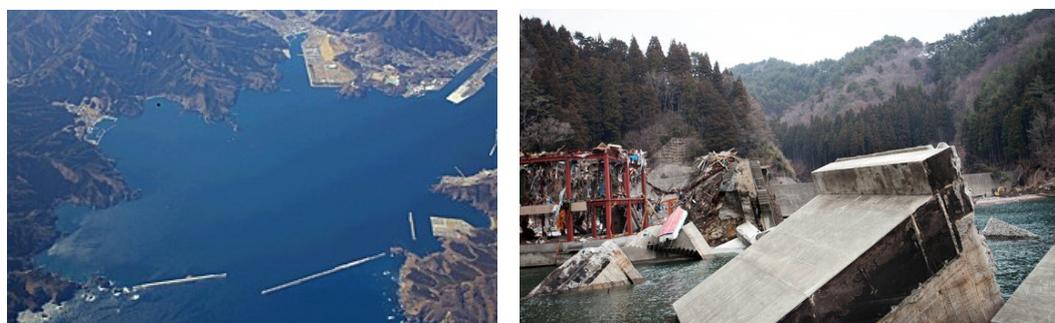
Figure 11: Damage of the worlds' deepest breakwater in Kamaishi, left before damage, right, after damage (Source: www.nytimes.com, <http://community.guinnessworldsrecords.com>).

It is obvious from the massive devastation that most of these structures failed to some extent or completely. According to Ogasawara et al. (2012) 25 of 55 tsunami barriers in Iwate prefecture were damaged and also almost half of the disaster prevention infrastructure has been destroyed. Even the breakwater installed in Kamaishi, being the deepest break water in the world (1950 m long and 63 m deep), was heavily damaged (Figure 11).

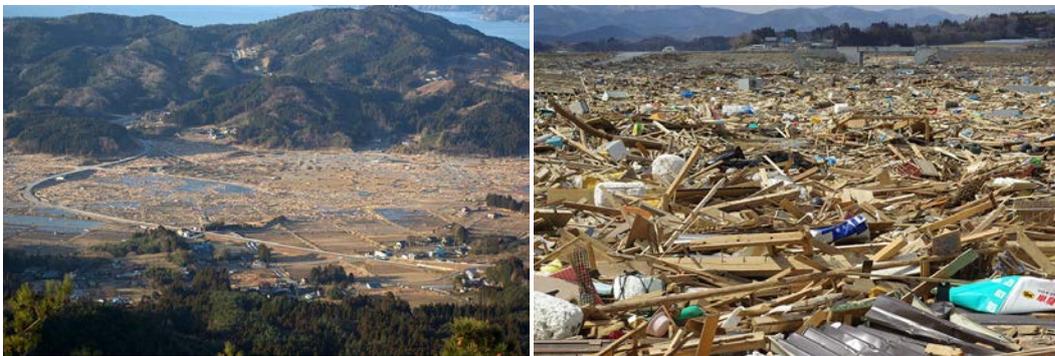
Figure 14: Rikuzentakata was totally flushed away by the tsunami (Photo: M. Sato, Wikicommons).

flooded might underpin that the effect of flotsam is rather significant. The highest percental number of fatalities occurred in Rikuzentakta (11.65%) and Otsuchi (11.57%). In these places also the highest water levels were measured, because of the steep ria coast valleys channeling the water and leading to a huge pile up of water. The strong wave impact and the high water levels have led to a total destruction of the coastal communities, which just flushed away, including all refugee locations (Leone et al. 2010). Since only 1.99% of the city Otsuchi were inundated (Table 2) the destructive wave height is obviously the reason for the high number of fatalities in a rather small area. Also here flotsam from destroyed houses, structures, and forests is supposed to have contributed to the number of fatalities (Figure 14).
