# Relation between inundation depth and damage of structures due to the 2011's Tsunami

The report by city bureau of MLIT

# Relation between inundation depth and damage of structures

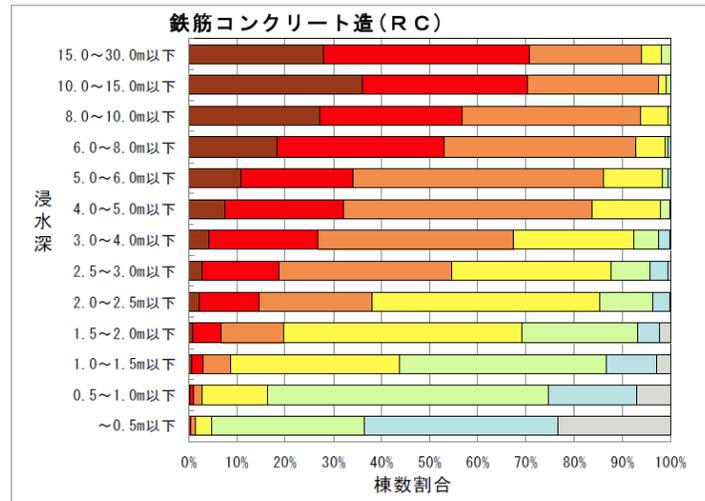
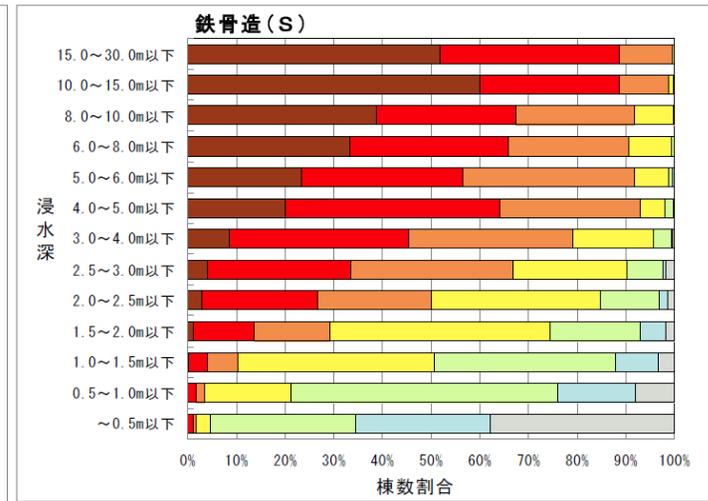
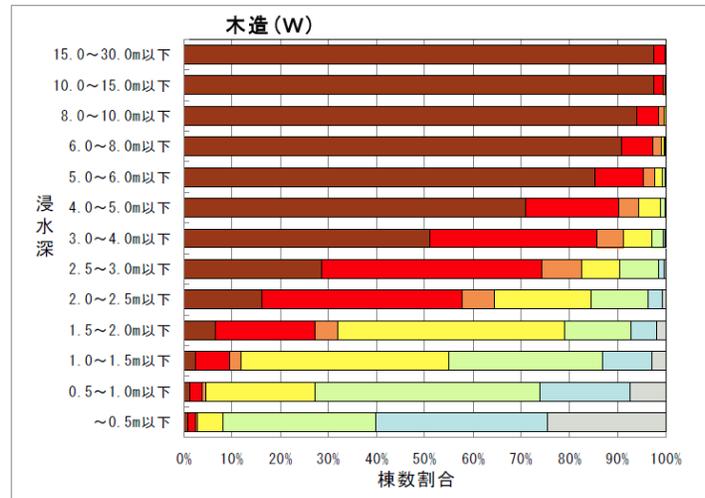
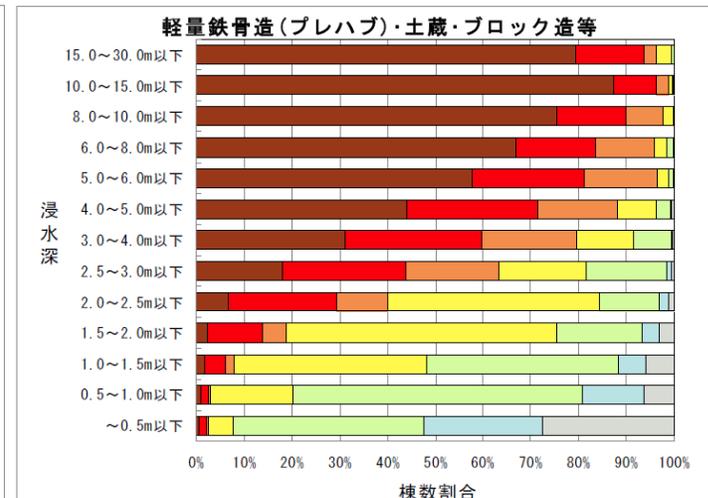
## Kind of structures

- 凡例
- 全壊 (流失)
  - 全壊
  - 全壊 (1階天井以上浸水)
  - 大規模半壊
  - 半壊 (床上浸水)
  - 一部損壊 (床下浸水)
  - 被災なし
